Method to Estimate the Aging of Large Rubber Marine Fender

ABSTRACT

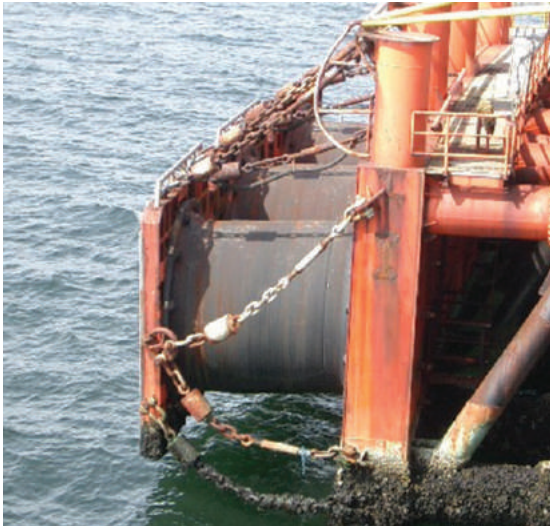
The direct way to know the fender performance after aging is to pick up the used fender from the site and test them. The NOSB in Japan have been conducting the compression tests in every 5 to 10 years for the circular shaped buckling fenders which are working for the mooring of large oil storage tanks. These fenders have not experienced the extreme deflection such as abnormal berthing which many fenders for berthing have. This is a good opportunity to study the pure aging by time and environment. The same type of circular shaped buckling fenders which had used in the offshore dolphins for the VLCC vessels also picked up and tested at the time of renewals. Fig.1 shows the example picture of circular shaped buckling fenders which is 3m high (3000H) in the VLCC dolphin.

Fig. 1 Circular shaped buckling fender: 3000H

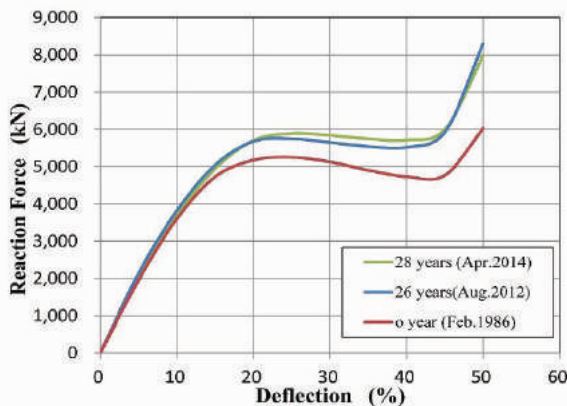
“Guideline for the Design of Fender Systems” by PIANC (2002) advised that fenders which have the reaction force more than 1MN have to have the compression at the time of delivery. So, those fenders should have the initial performance for reference. Fig. 2 shows the example of fender performance before and after 28 years of use in the Kamigoto National Oil Storage Base (NOSB-Kamigoto). In the deflection from 0 to 20%, the cylindrical body is compressed with its

Fig. 2 Aging of fender performance: 3000H

shape but it buckles and reaction force becomes flat when the cylindrical body swells radially. Then after 45%, the reaction force steeply goes up when the cylindrical shape is almost crashed. This is the typical characteristics of this fender to absorb as much kinetic energy which is the area between the curve and x-axis within the smallest reaction force. In order to see the tendency, the aging rate of reaction force is defined as the reaction force at 35% compression divided by the initial value at 35%. The aging rate of reaction force by years is shown in Fig. 3. The regression line increases roughly 0.3% per year and the upper and lower limits of confidence interval are shown in red broken lines.

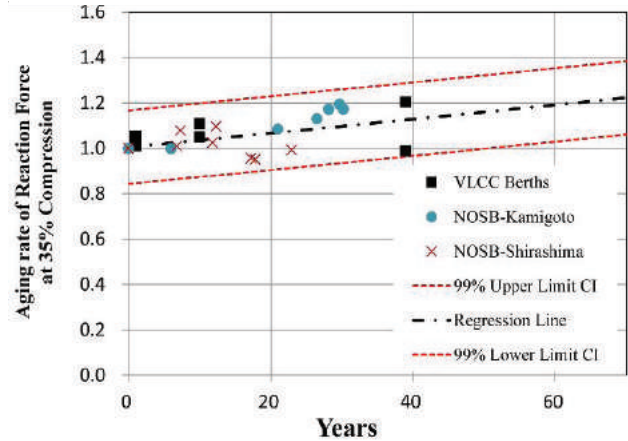
Fig. 3 The aging rate of performance by years

The aging rates of reaction force which were added to Fig. 3 are now shown in Fig. 17. The curve of model (Blue solid line with triangle plots) increases to 10 to 20 % higher than the regression line of test results in the first 20 years then becomes parallel and close to the 99% upper limit CI of test results after 20 years. The test results of used fenders do not show the first increase. Possible reasons are:

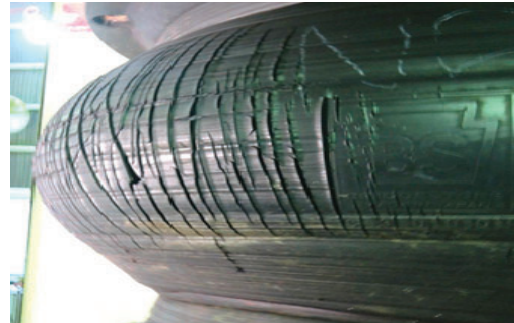
Fig. 4 shows the surface cracks under compression of the VLCC fender. Fig. 5 is the close up photo of cracked surface after compression. The cracks are limited in the skin rubber and do not look extending to the inner body.

Fig. 4 Surface cracks under compression (3000H, 39 years)

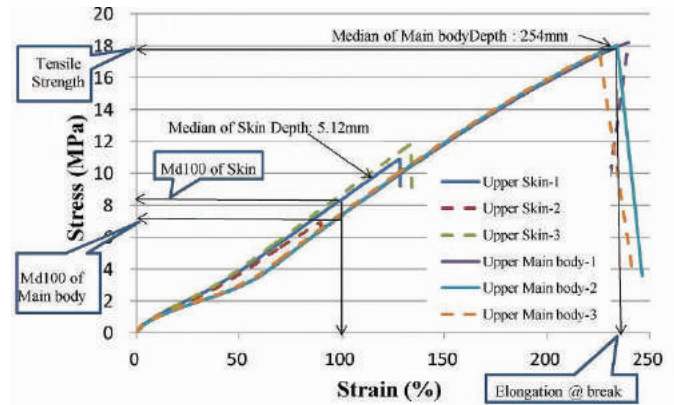
the procedure of JIS Standards; K6250 (2006), K6251 (2010) and K6253-3 (2012). The example of result is shown in Fig. 8. The samples were 2mm thick and the median of three specimens were used to determine the tensile strength and elongation at break. The skin rubber was at the depth of 5.12mm and the main rubber sample is at the depth of 254mm. The tensile strength and elongation at break are defined as shown in Fig. 8. The elasticity seems to reflect the performance most but the stress-strain relation is non-linear as shown in Fig. 8. So, the stress at the 100% strain (Md100) is defined as in Fig. 8.

Fig. 8 Example of material test data

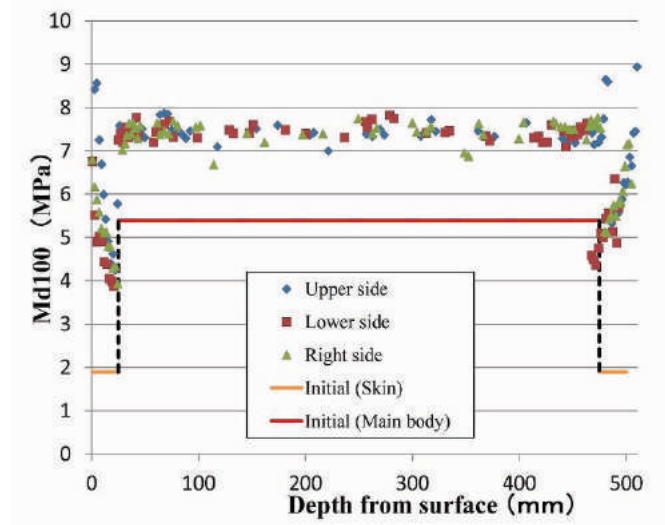
The distribution of Md100 in each depth from the outer surface is shown in Fig. 9. While the sharp increase of Md100 is shown near the surface, the Md100 in the main body is flat. This is a similar phenomenon as explained in Fig. 6. Itoh et al., (2006) defined the critical depth where the rubber deteriorates quickly and prevent the further deterioration of the inner rubber. They explained "When the vulcanizing sulfur crosslinks are subjected to oxidation, the crosslinks will break up, the chains will re-entangle and form more new crosslinks which makes the motion of chains impeded and results in high hardness, low elongation and brittle fracture of the material". The flat and moderate increase of Md100 in the inner part is a different chemical reaction of oxidation but looks like a slow vulcanizing of sulfur crosslinking in normal temperature.

Fig. 9 Distribution of stress at 100% strain: Md100

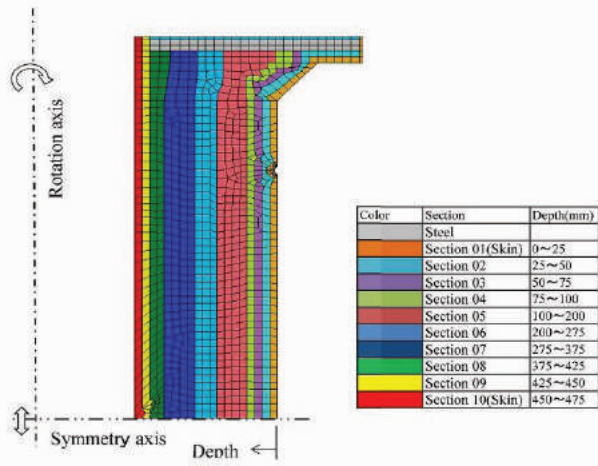
The material properties obtained in the previous section are used to estimate the fender performance before and after aging. The commercially available FEM software called ABAQUS is used for the analysis. Yeoh's theory (1997) was chosen as the constitutive model. The element model is shown in Fig. 10. The fender is axisymmetric around the center rotation axis and plane symmetric vertically so only one quarter of body needs to be defined. Section 1 and section 10 are skin rubbers and sections from 02 to 09 are main body.

Fig. 10 Element layers for FEM

The properties after aging are distributed as shown in Fig. 10. The viscosity is ignored so only stress-strain relations in Fig. 11 are defined. In Fig. 11, the color solid lines are the properties of aged rubber at the different depth. The black broken line shows the initial properties before aging. The calculated reaction force at each deflection is shown in Fig. 12. Comparing to the actual compression in Fig. 2, the reaction forces both before and after aging is higher. The several reasons can be considered for this difference. The performance in Fig. 2 is the average of 2nd and 3rd compression where the FEM result in Fig. 12 does not consider the compression history. Also the viscosity of rubber is ignored. We have the initial performance before aging and the purpose of this analysis is to estimate the effect of aging to the initial performance. So, we estimate the performance after aging by multiplying the rate between before and after aging of FEM results. The result is shown in Fig. 13. The after aging (Green line) and estimated by FEM (Blue line) matched well to the test result.

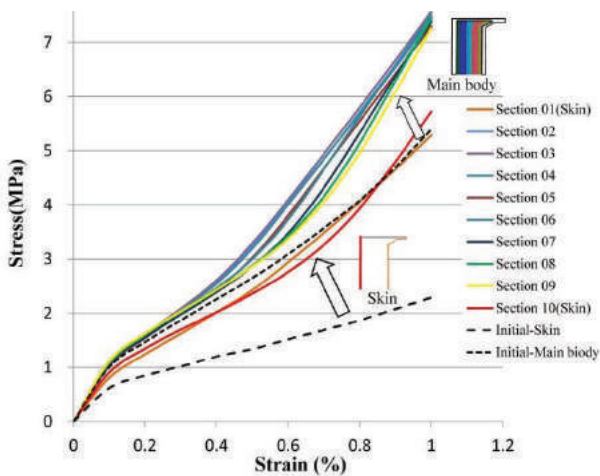
Fig. 11 Material property for FEM

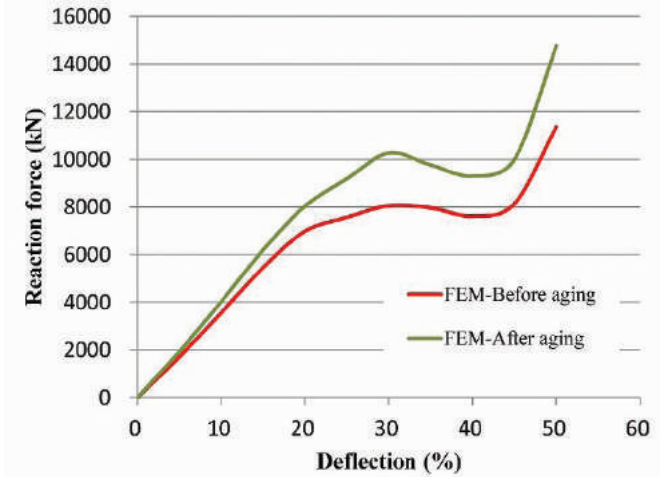
Fig. 12 Fender performance by FEM: 3000H

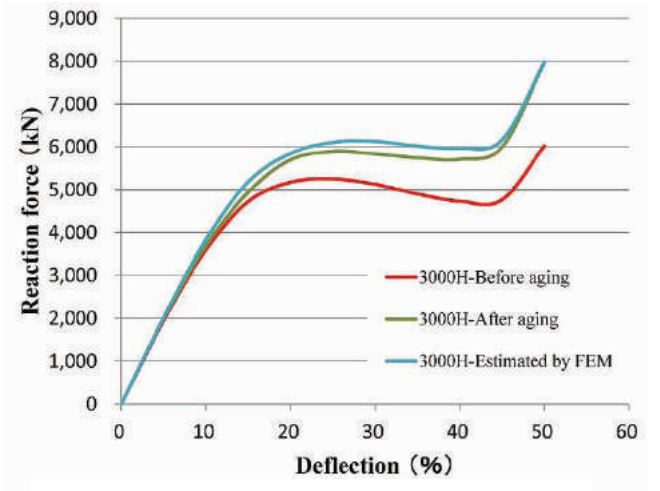
Fig. 13 Estimated performance by FEM

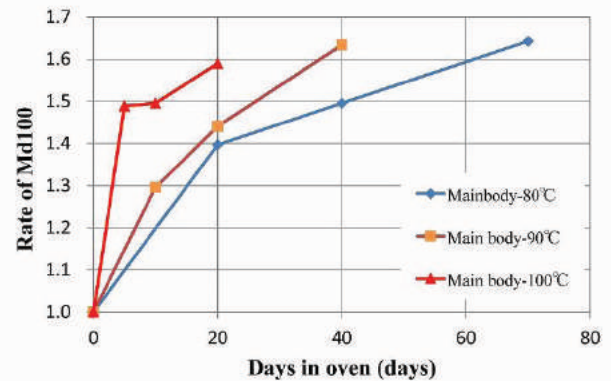
The thermal oxidation was given to the rubber material to accelerate the aging and to obtain the relations among the different temperature by calculating the activation energy assuming the Arrhenius's law. The 2mm thick sheets made of same rubber used for the fender were put in the oven which was controlled at 80, 90 and 100 degree Celsius for the duration from 1 to 350 days. The hardness, tensile strength and elongation at break were tested. The activation energy differs depending on which character is chosen. Here again, considering the purpose is discussing the performance of fender, Md100 was chosen. The values of Md100 of main body and skin rubber are shown in Fig. 15 and Fig. 16, respectively.

Fig. 15 Accelerated aging of Stress at 100% strain (Md100) -Main body

The activation energy is obtained as shown in Table. 1. The values differ depending on the rate of Md100. The skin rubber broke before being stretched to 100% strain at the rate of 1.5 so there is no data of skin rubber at 1.5 in Table. 1.

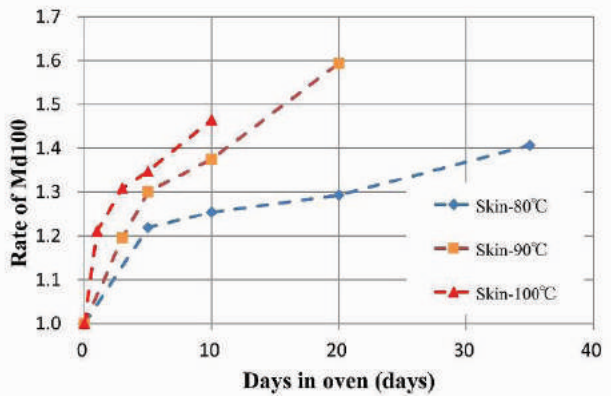
Fig. 16 Accelerated aging of Stress at 100% strain (Md100) -Skin

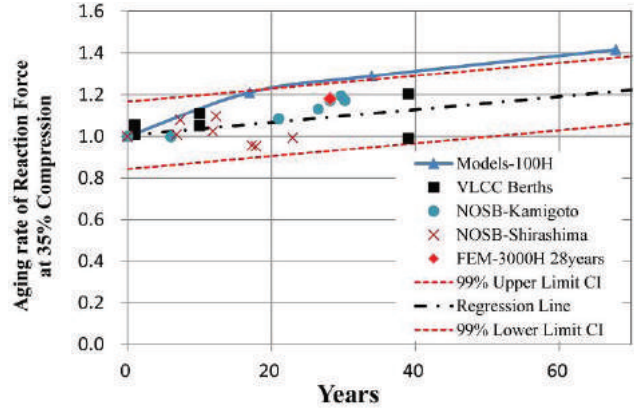
Fig. 17 Rate of reaction force (100H model & FEM)

A: The rubber thickness of real fender is from 400 to 500 mm when the model thickness is about 15mm. So, the oxidation could be faster in models than actual size fender. This could be improved by non-oxide environment such as nitrogen sealed both for material sheets and models.

B: The range of temperature: 80~100 degrees Celsius (°C) may be a little too high and some chemical reaction other than the 1st order oxidation might have affected. This could be improved by adding the lower temperature (70, 60°C) condition, if time allows. Although a little bigger values of reaction force should be acceptable for safety from the design point of view, the further improvements will be planned in future study.

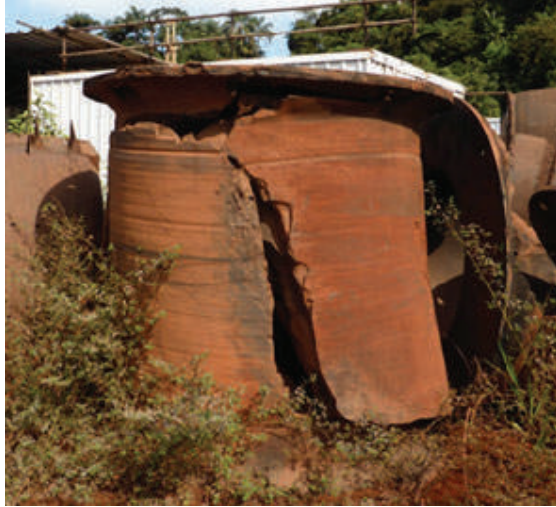
A similar destruction mode was observed in South America (2012) for the 2000H (2m high) fender after 42 years of use. A large compression was seen and reported when this fender was suddenly broken. The average temperature of this area is 23.3°C. 42 years is much shorter than 67.8 years but we should be noted that this type of sudden destruction could occur even if the fenders visually look sound. Fender should be replaced before the material is deteriorated this much.

Fig. 19 Broken actual fender: 2000H (42 years)

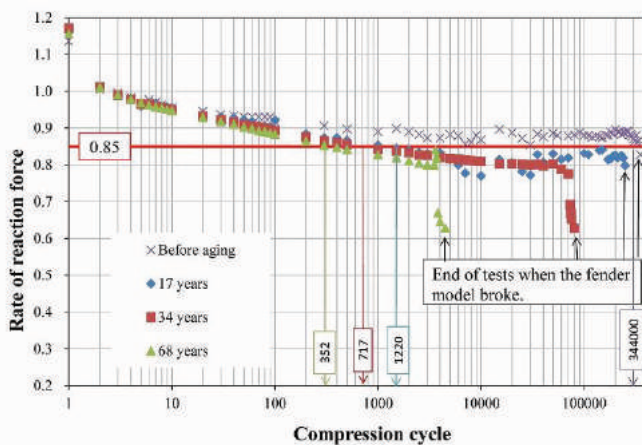
Fig. 20 shows how the rates of reaction force at 35% drop by the number of compression cycle. The rate 1.0 is the average of 2nd and 3rd compression. Every test was finished by both the sharp drop of reaction force and the crack penetrated through body.

Fig. 20 Fatigue tests of model fenders

The aged fenders drop earlier and break earlier than new fender. Murata et al., (2009) suggested defining 85% of initial performance as the limit of service life. This is shown as a red line in Fig. 20. Each cycle at 85% and break are shown in Table. 3.

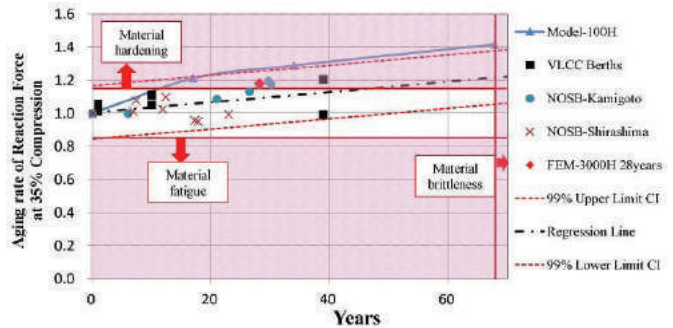
Thus, the aging of large rubber fender has been studied from three aspects; testing of used fender, FEM by material from used fender and accelerated aging of models. The possible design concept of fender aging is demonstrated in Fig. 21. Omura et al., (2014) reported that in the NOSB projects, the design range of fender was determined from 0.85 to 1.15 times of the initial performance. Assuming the upper design limit of reaction force factor is 1.15, the regression line crosses over at 47 years of use. The lower limit is described by the number of compression cycle in Fig. 20, so the years until the reaction force drops to 85% of initial performance needs to be estimated from the berthing frequency of each port. The models over 67.8 years of accelerated oxidation broke at the 1st compression. These limits are shown in Fig. 21 as red lines and pink area.

Fig. 21 Limits of fender reaction force by years
